2014-2015 Facilities Assessment and
Deferred Maintenance Capital Planning Report
Phase 3 Update

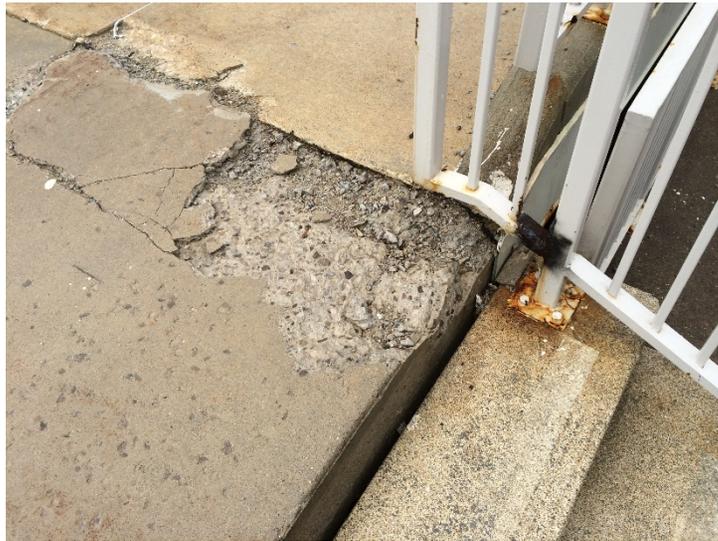
Site steps and supporting structures are failing.

- Repair or replace metal railings around building's exterior.
- Elevated concrete walkways are showing signs of significant water damage and must be repaired.
- Repair the concrete slab at the South entry that is negatively pitched and causing water to flood the vestibule.
- Repair or replace significantly cracked and deteriorating concrete pavers surrounding the building.
- Repair or replace concrete steps and supporting structures that have deteriorated significantly.

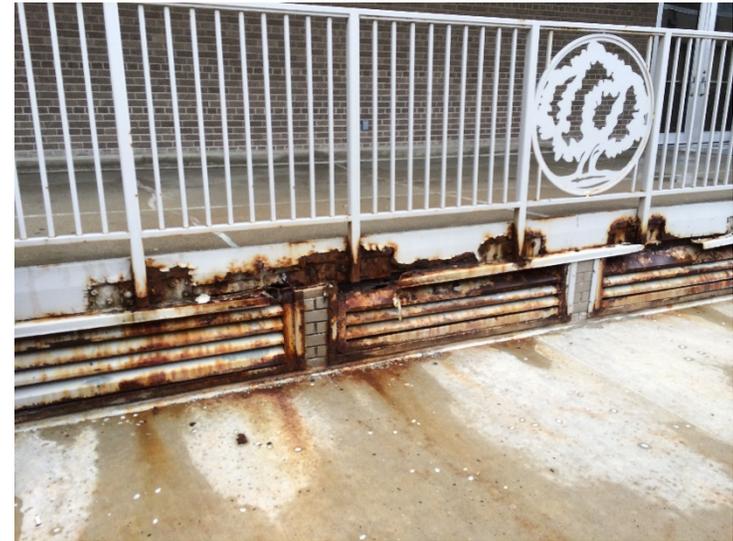
Water damage and infiltration at HVAC system louvers.

- HVAC Louvers are rusted/corroded and deteriorating. Replace louvers.

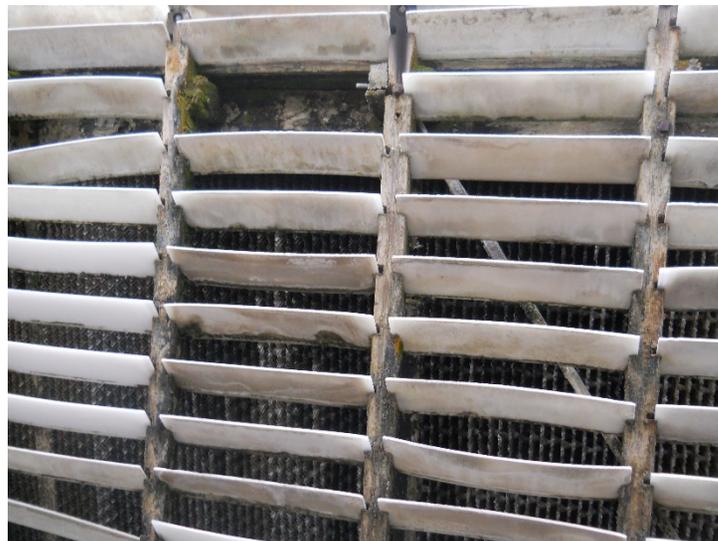
Wooden-structure cooling tower is original to the building and in extremely poor condition.

- The roof-mounted cooling tower is well beyond its useful life, is in extremely poor condition and is outdated, inefficient technology. Replace cooling tower with new.

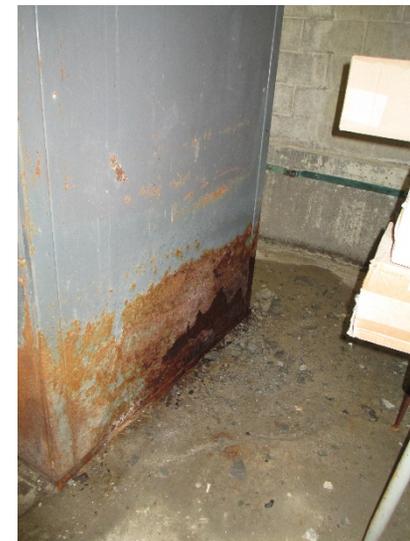
Electrical substation and power distribution equipment is severely corroded due to water infiltration.

The building’s electrical gear is well past its useful service life. Casings are corroded and pose a safety hazard.

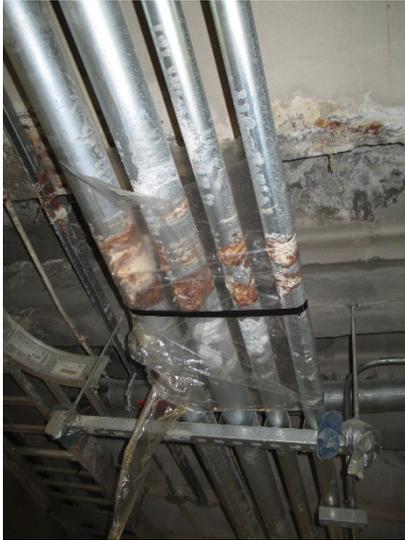
Substation feeders and conduits are severely corroded due to water infiltration and wrapped in plastic as a temporary fix.

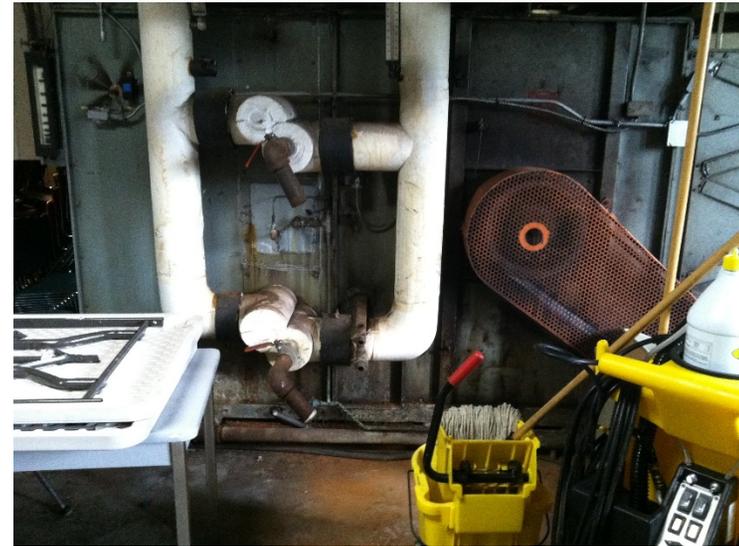
Air-Handling Units are original to the building and well beyond their useful life.

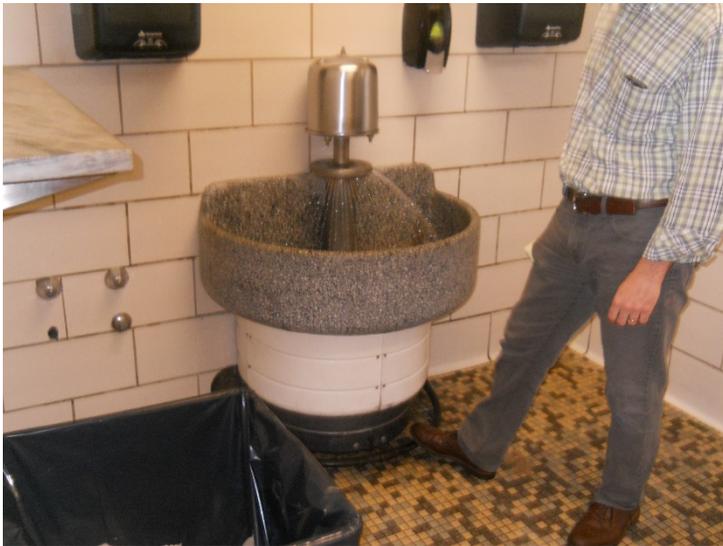
Wash fountains in toilet rooms are not compliant with ADA.

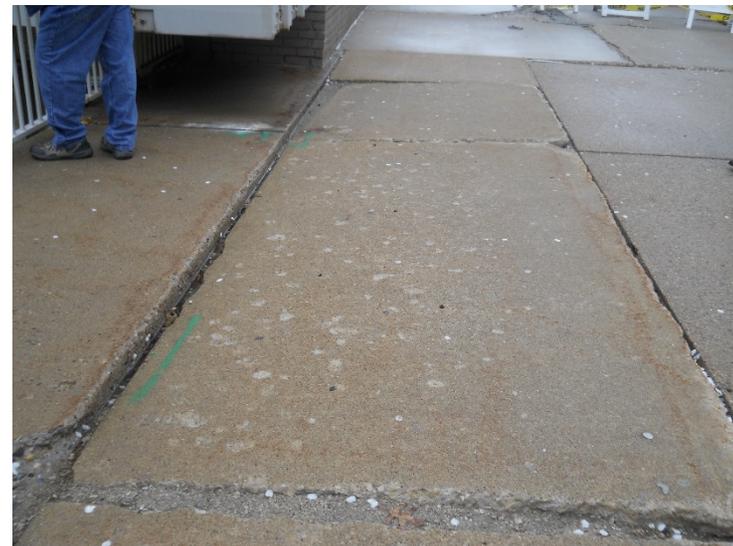
Site pavers surrounding building are cracked, heaving and deteriorated.

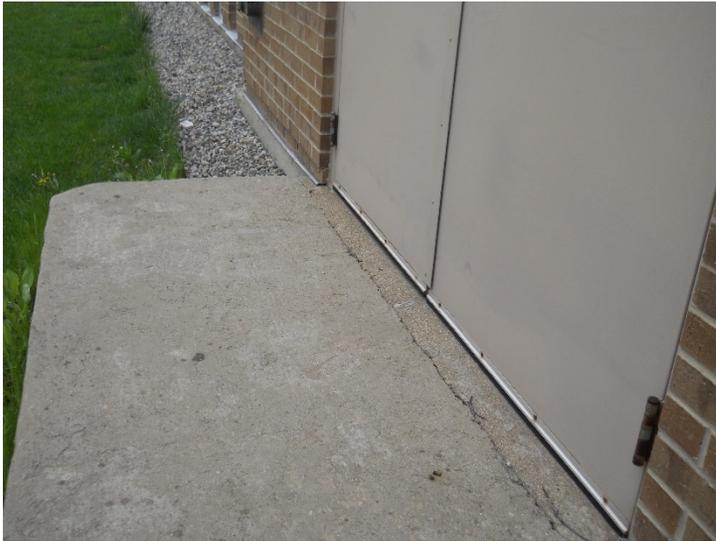
Concrete slabs heaving at East/West entrances.

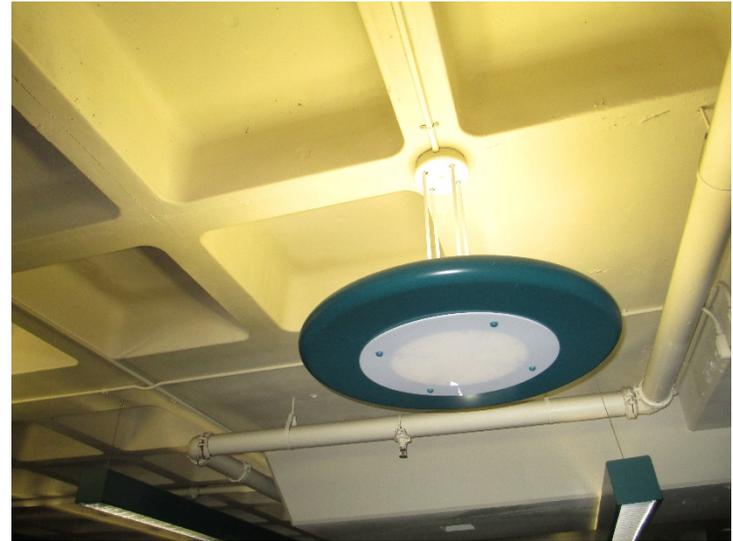
Peeling paint on waffle slab structure.

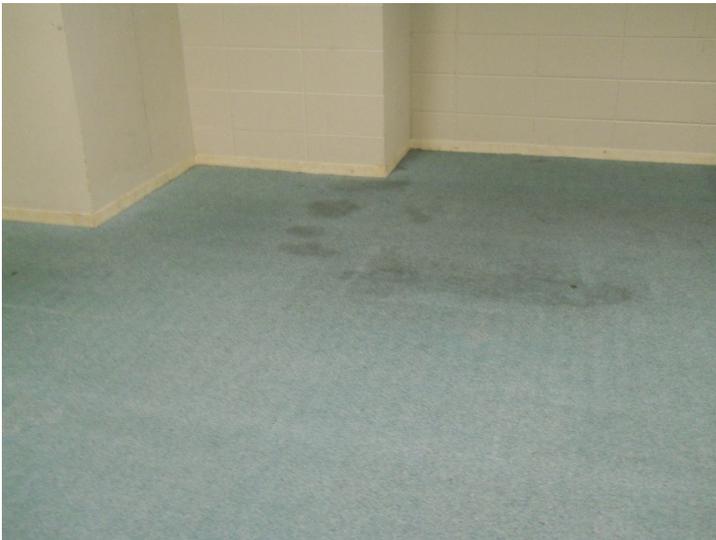
Carpeting is worn and due for replacement.

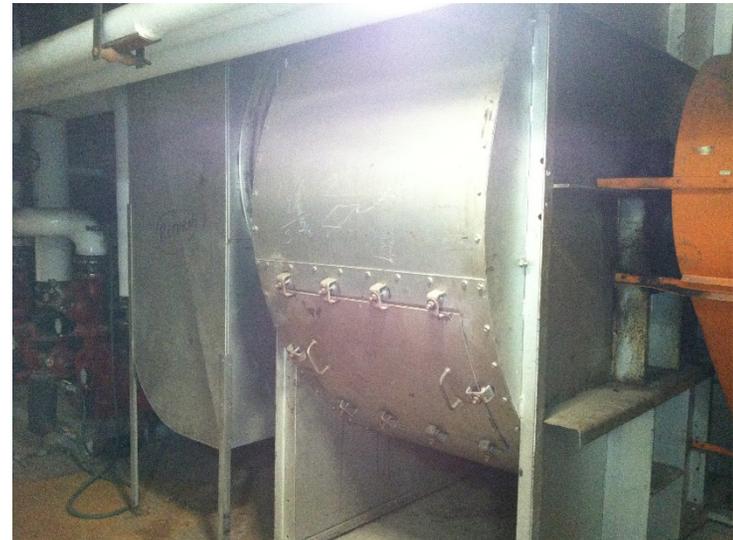
HVAC equipment is original to building and past its useful service life.

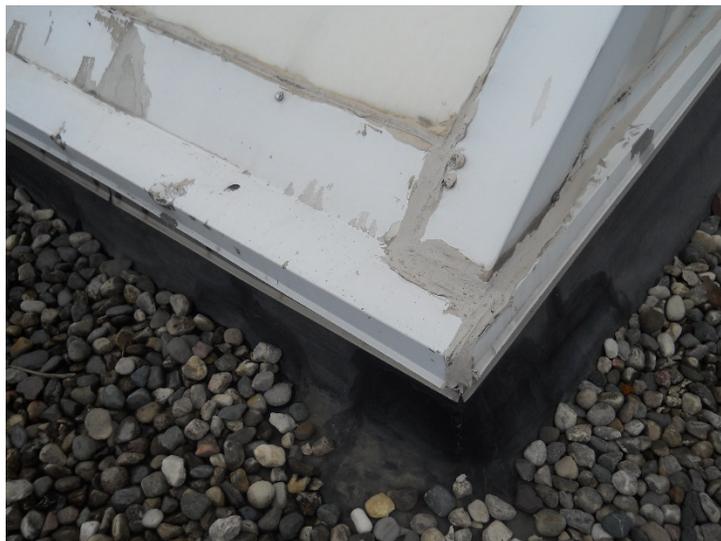
Skylights are showing signs of wear and water infiltration.

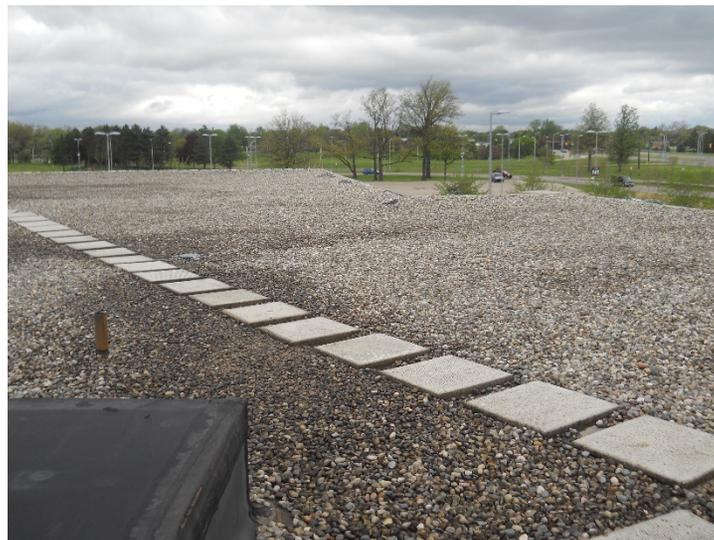
EPDM roof is past its useful service life and due for replacement.

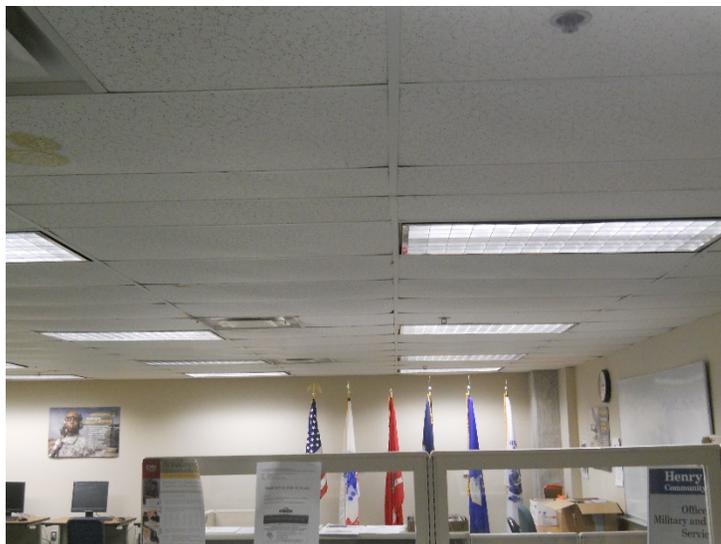
First floor counseling area – ceiling tiles are sagging and stained.

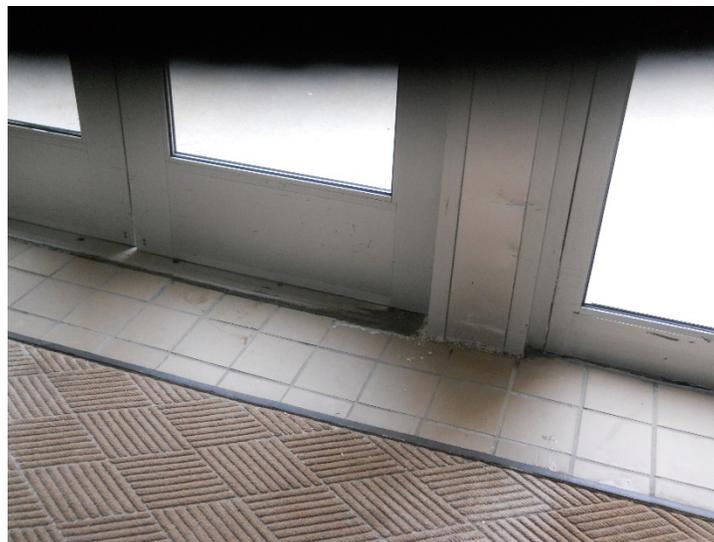
Entry door sweeps/seals are missing. Thresholds are deteriorating.

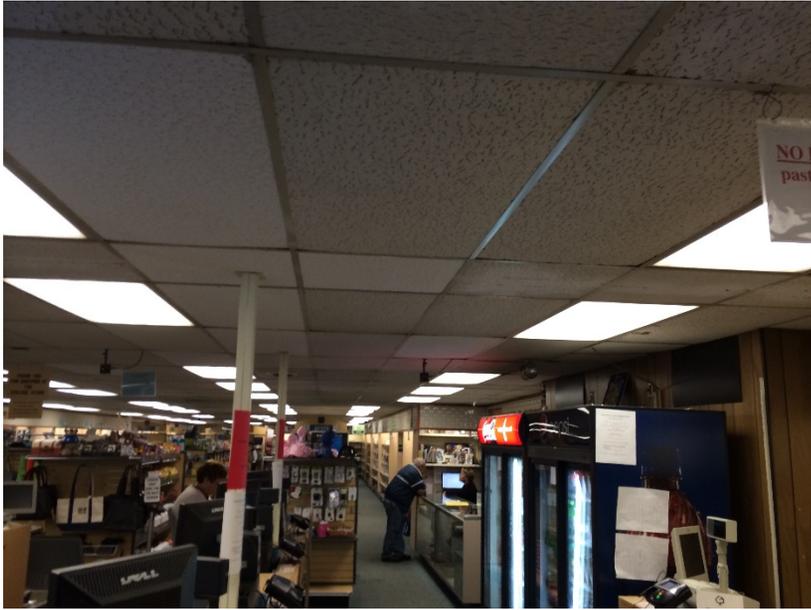
Ceiling and carpet are worn and need to be replaced.

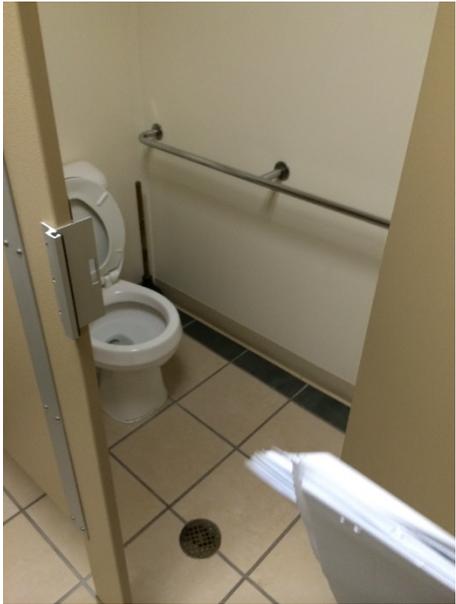
Non-ADA compliant toilet rooms.

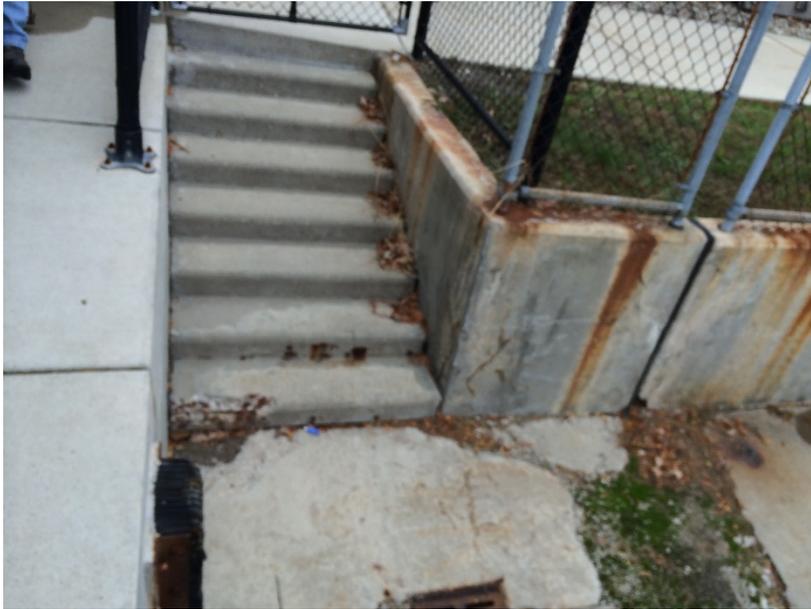
Damage at concrete loading dock.

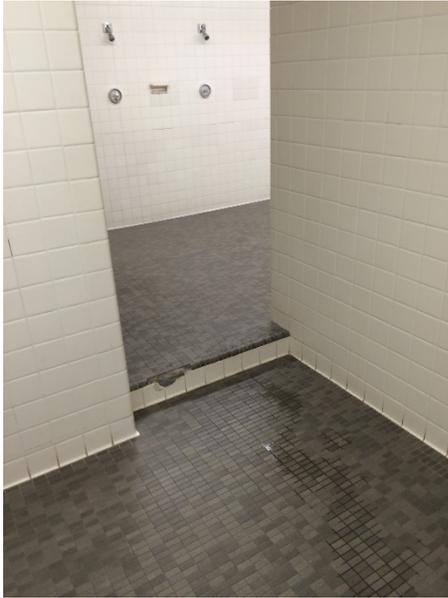
Non ADA compliant locker room.

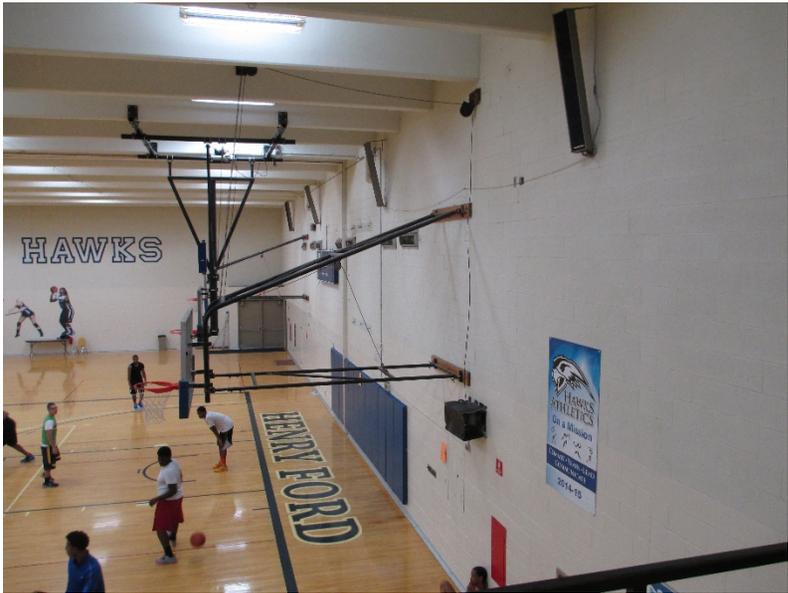
Gymnasium partition must be replaced.

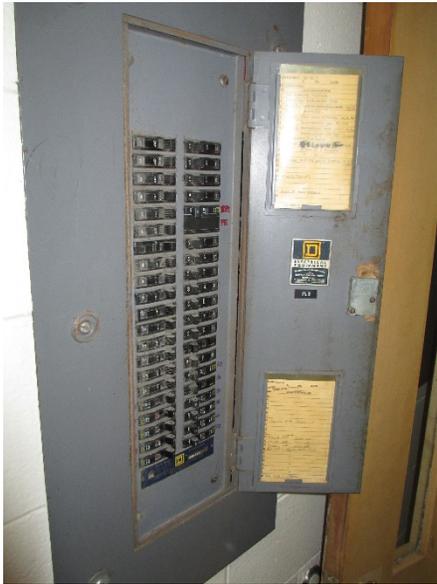
Panelboards in need of replacement.

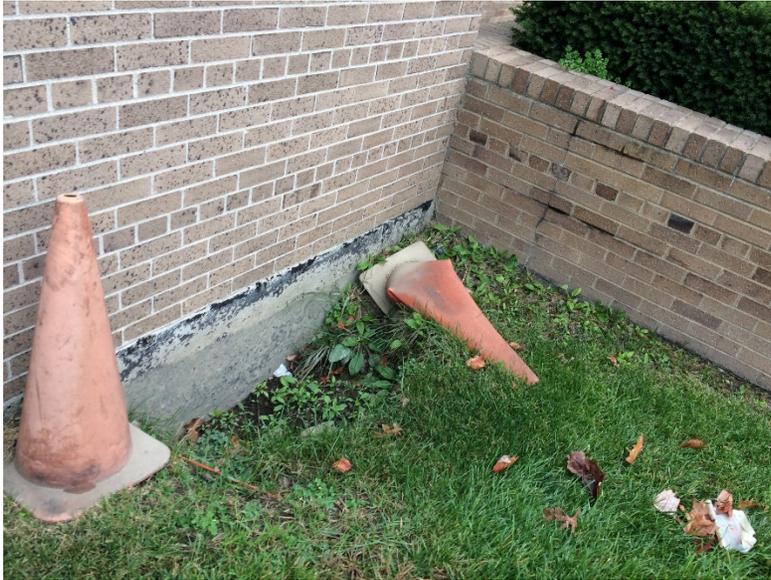
East lawn negative pitch and erosion.

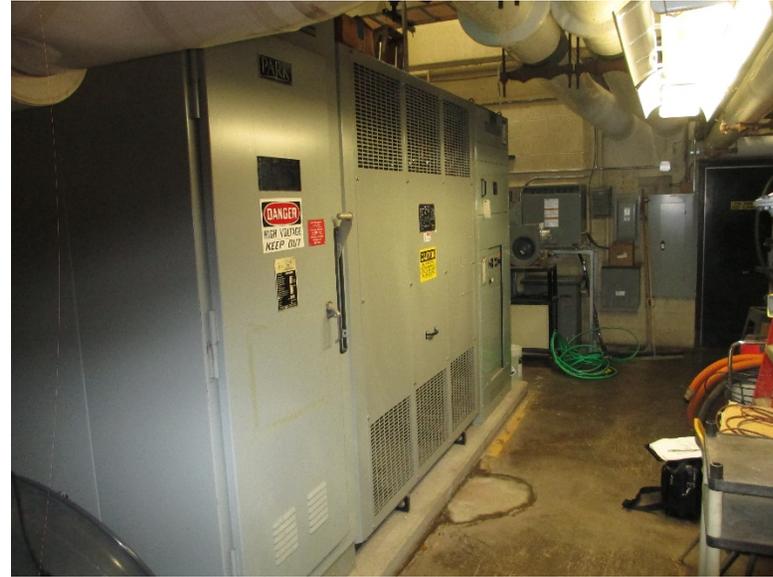
Location of substation creates potentially hazardous condition.

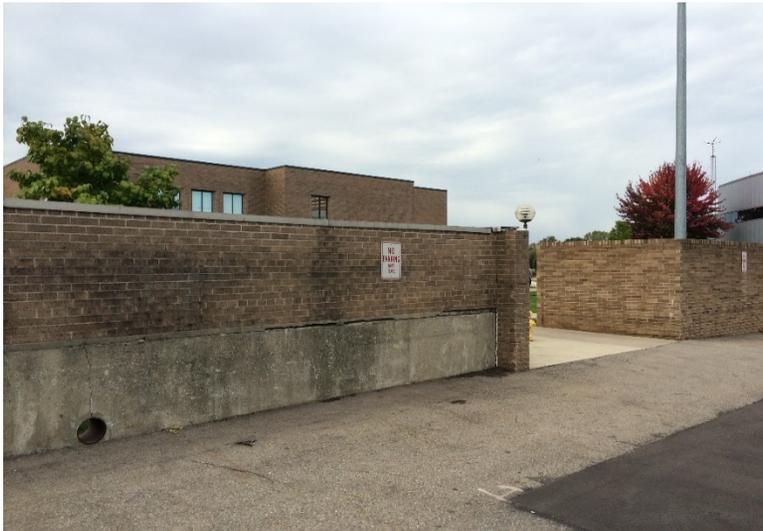
Deterioration at loading dock site wall.

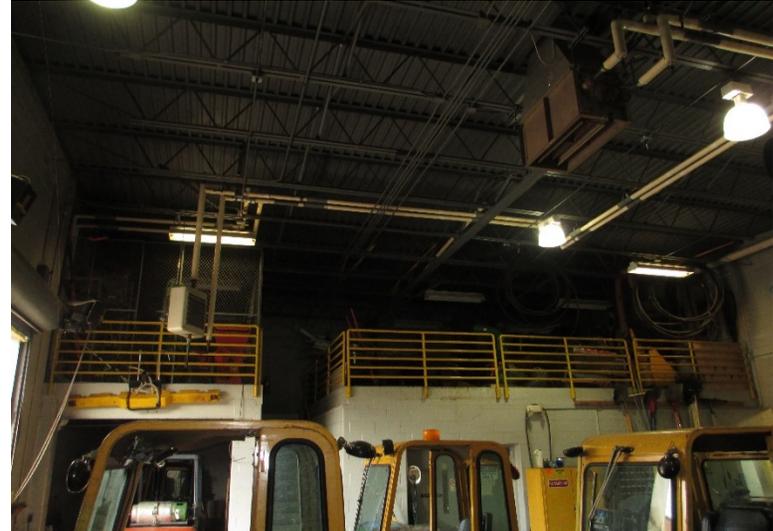
Light level in garage area is too low for working environment.

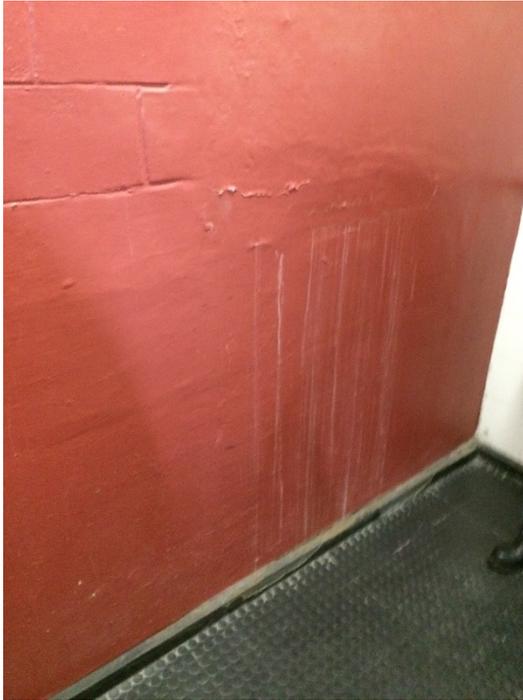
Water infiltration at stair.

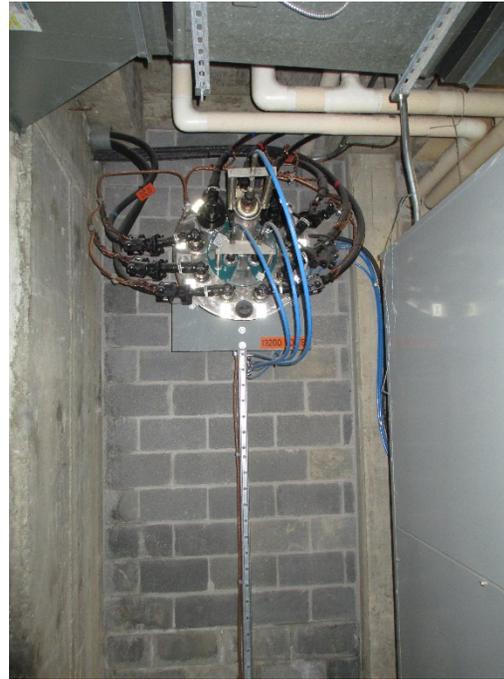
Location of loop switch to substation creates a potentially hazardous condition.

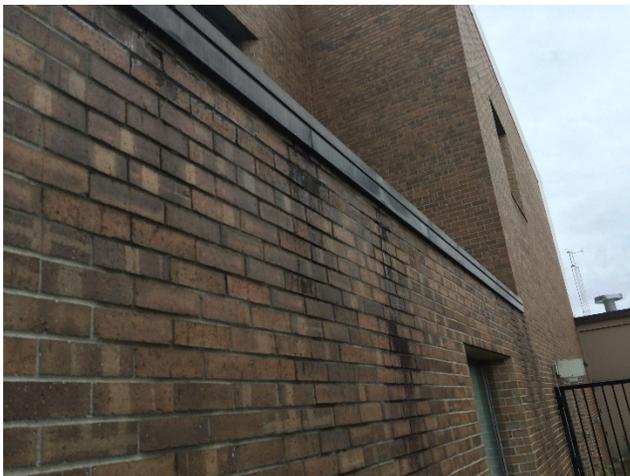
Skylight leakage above gallery.

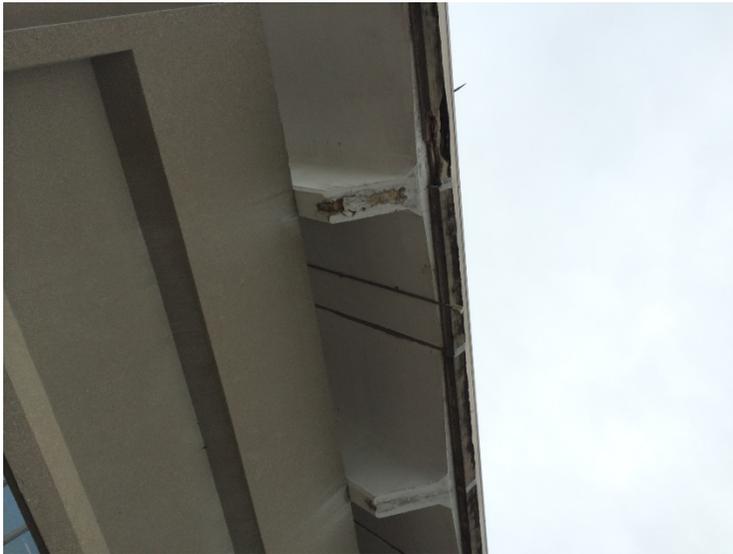
Detail at loading dock indicating concrete spalling.

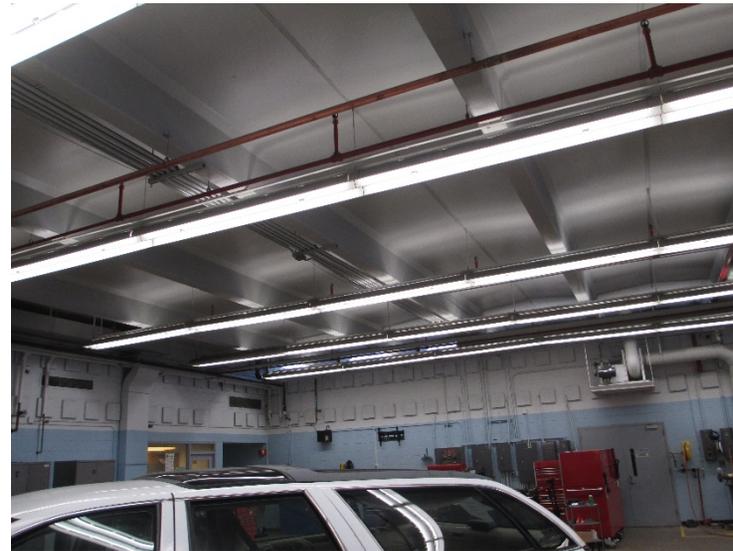
Socket failure at 8'-0" long fluorescent lights.

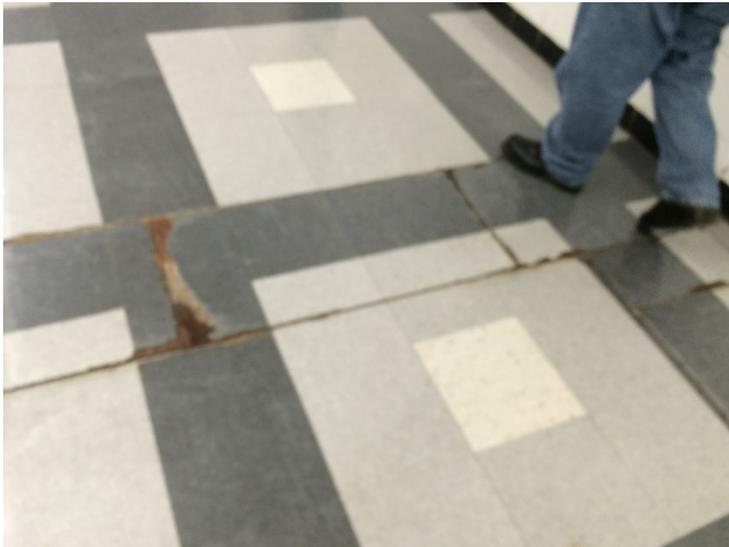
Detail of VCT deterioration at walker duct.

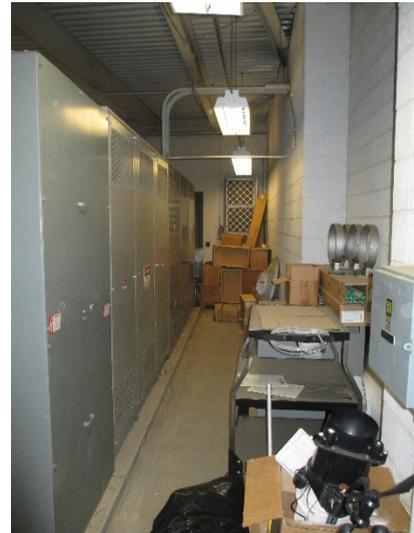
Electrical closet as shared storage space.

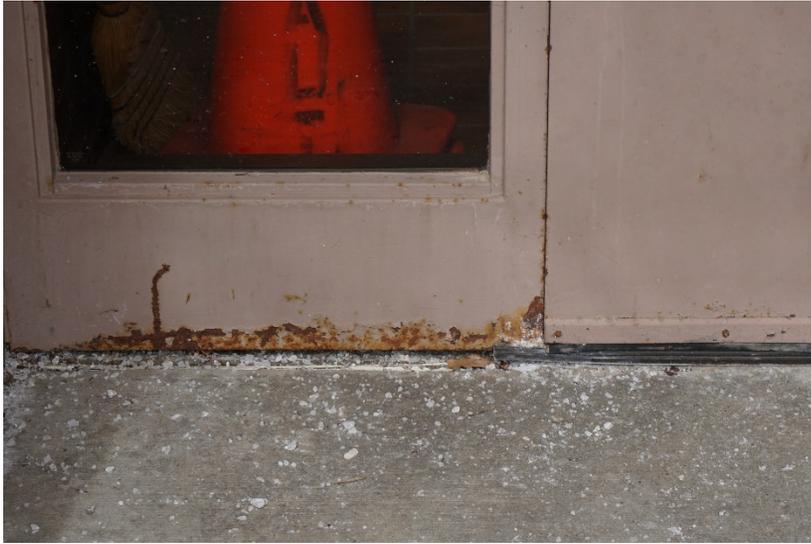
Example of door corrosion due to water and salt.

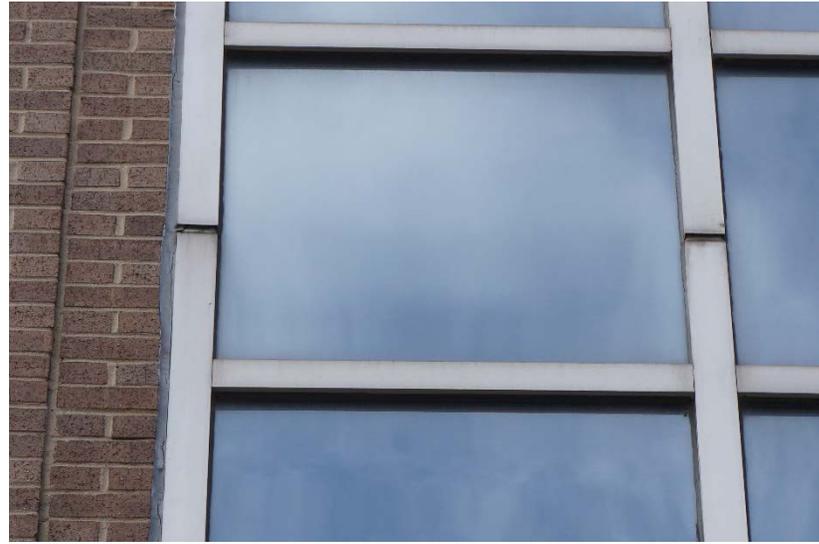
Curtainwall gasketing allowing water into building.

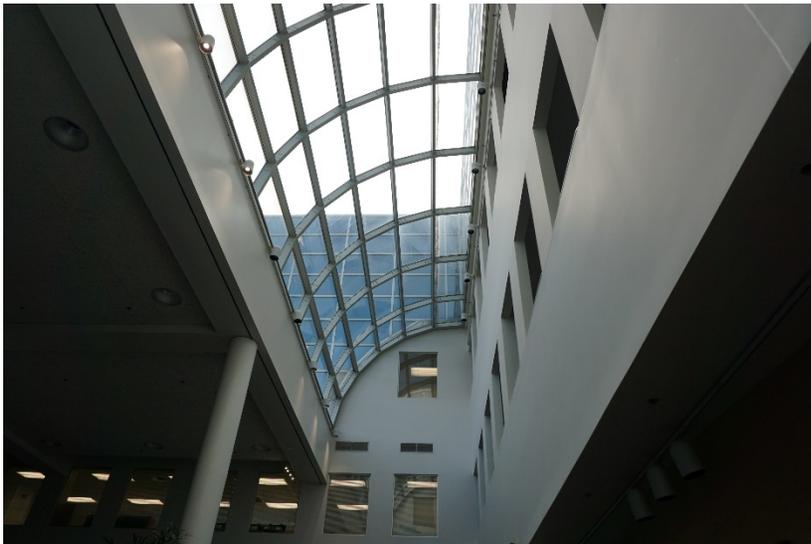
1998 skylight drainage system not working properly, leaking.

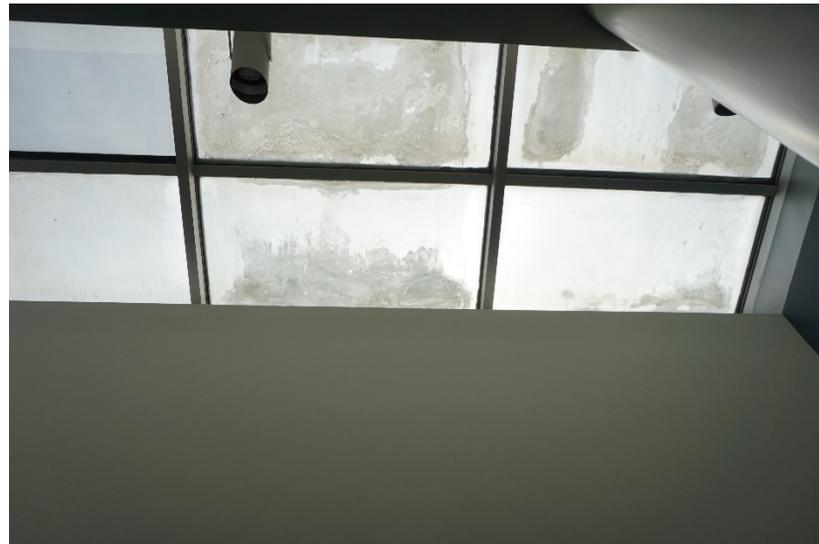
Skylight glazing between wings fogged and due for replacement

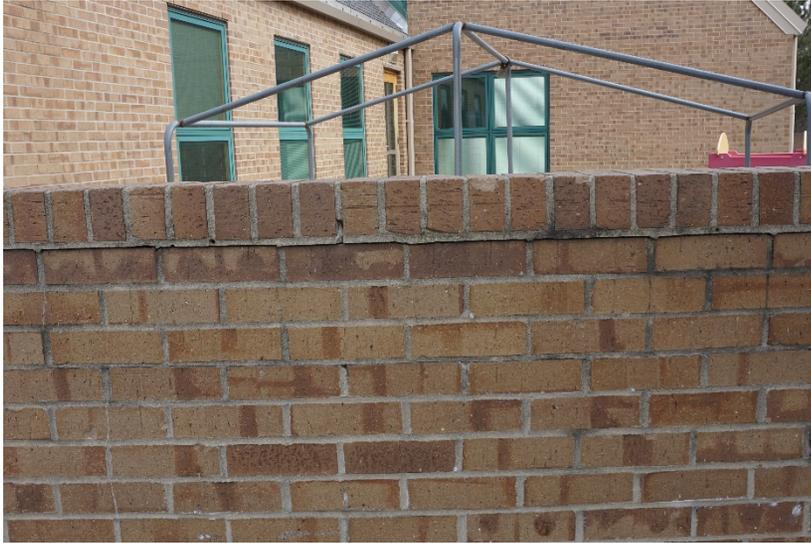
Loose brick wall cap, wall deterioration likely if not repaired.

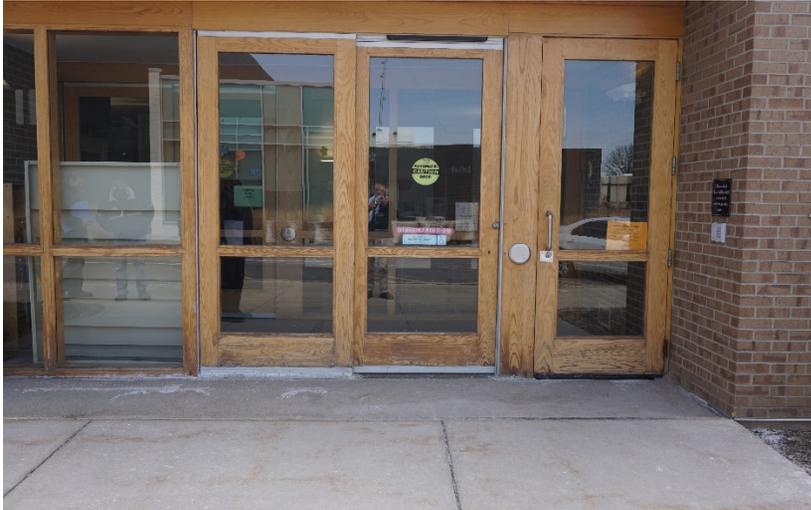
Deteriorated wood window and door finish. Problematic sliding door.

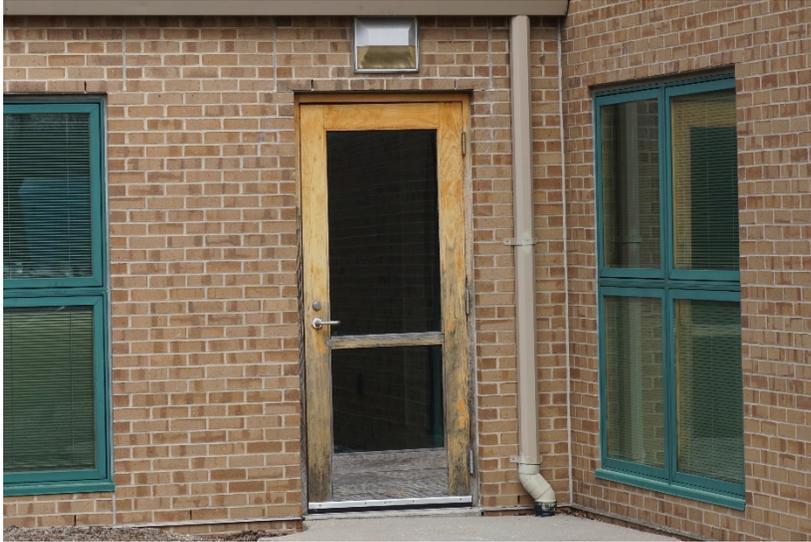
Deteriorated wood door finish.

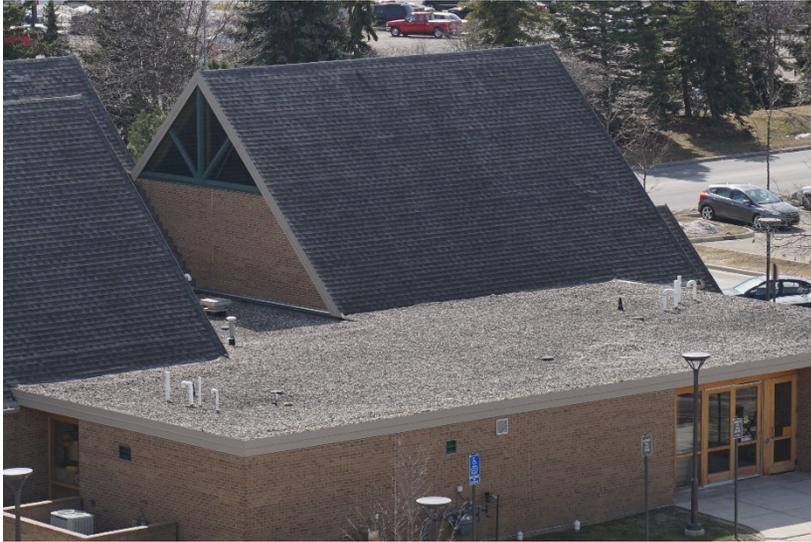
Flat and sloped roofs due for replacement.

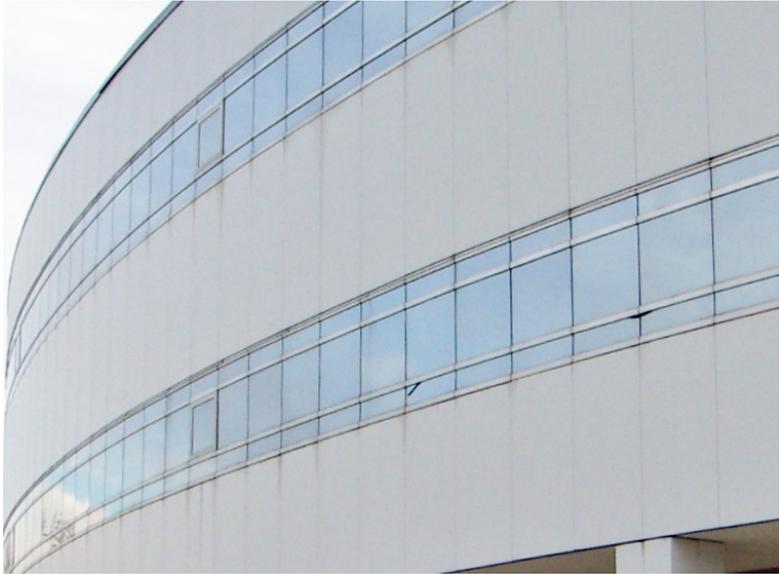
Metal panels – stained/dirty, with loose gasketing on windows

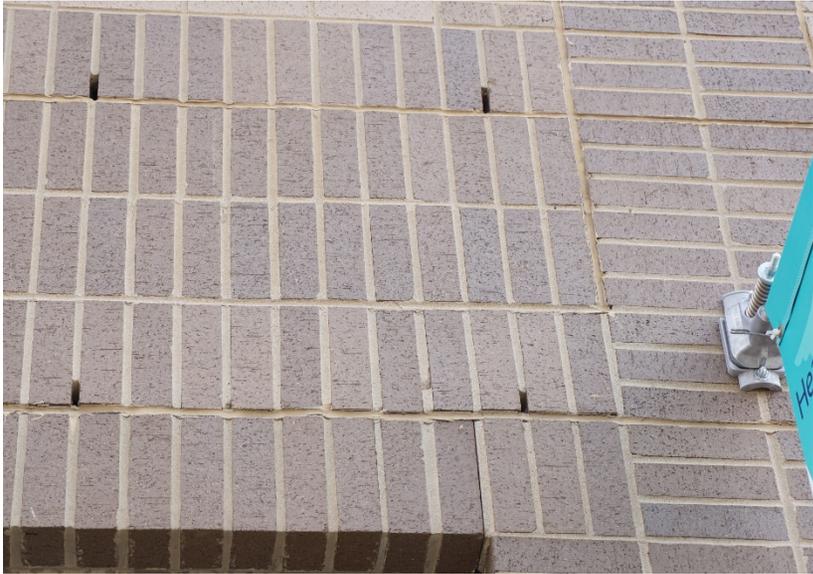
Detail showing past wall repair, including caulking at flashing.

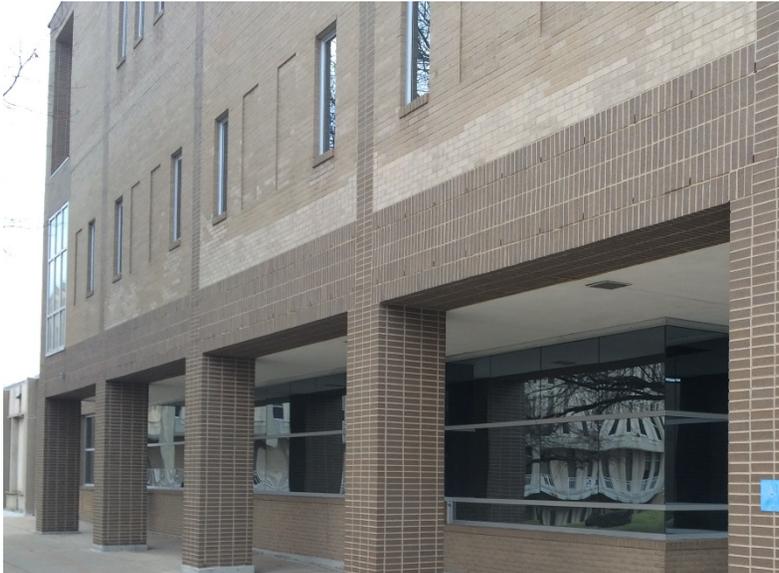
Area of past brick wall repair.

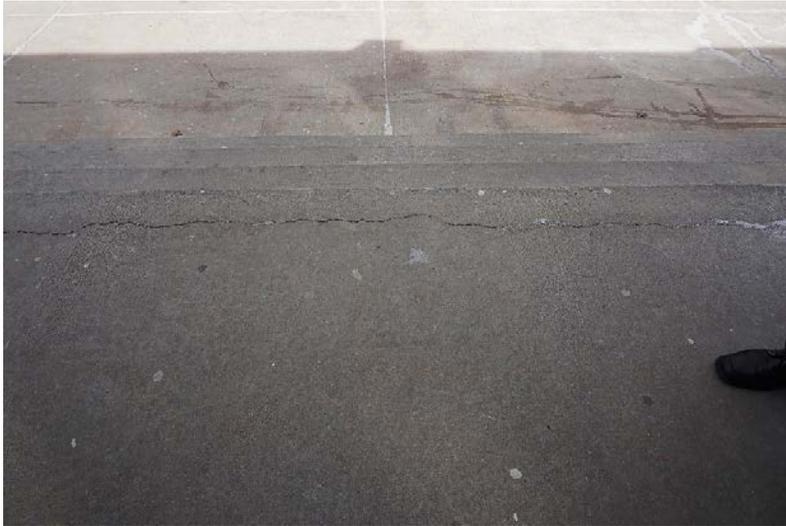
Concrete slab cracking

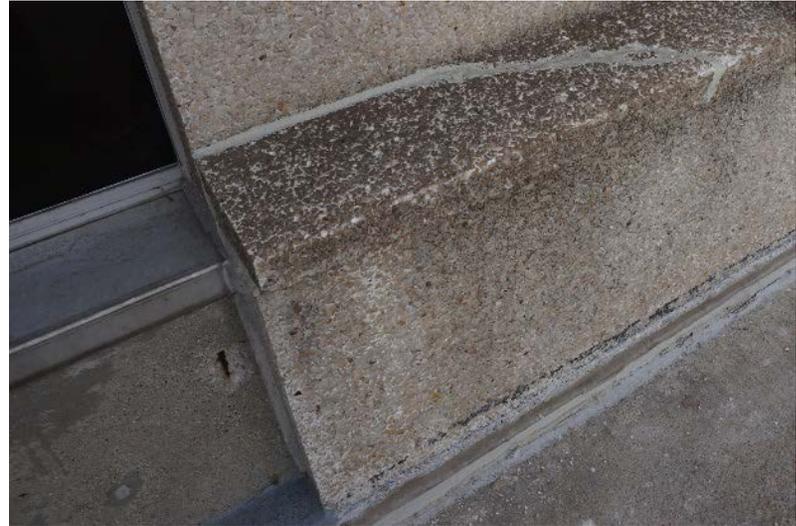
Exposed steel reinforcing, crack precast concrete wall

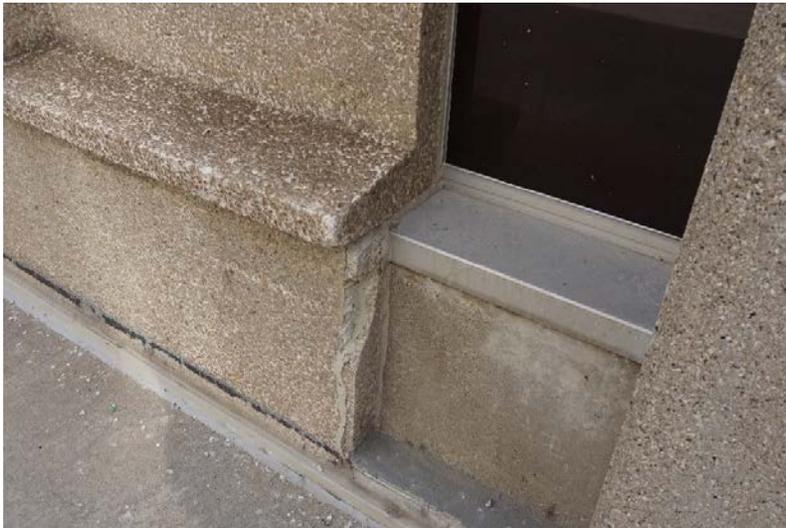
Broken precast concrete endcap

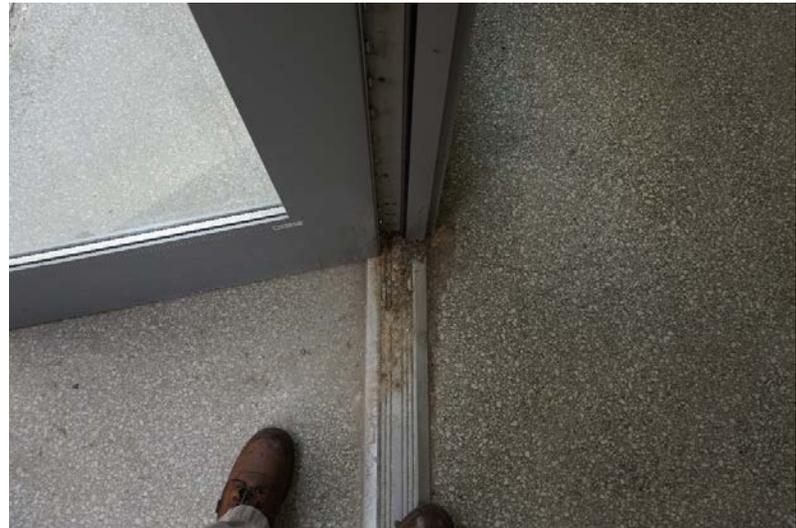
Corrosion on exterior aluminum door sill

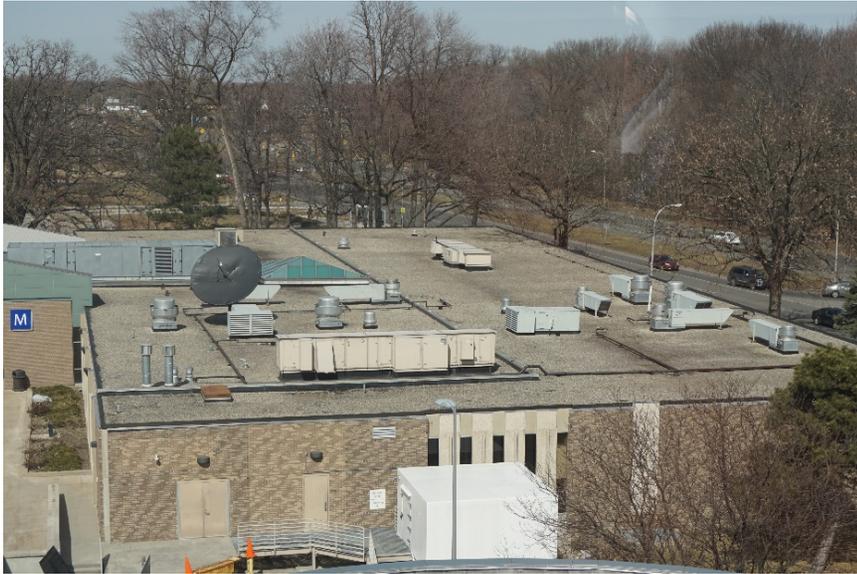
Roof membrane and mechanical equipment due for replacement. Rooftop unit at left edge of photo is not well aligned on its curb and has been a leaking issue for some time.

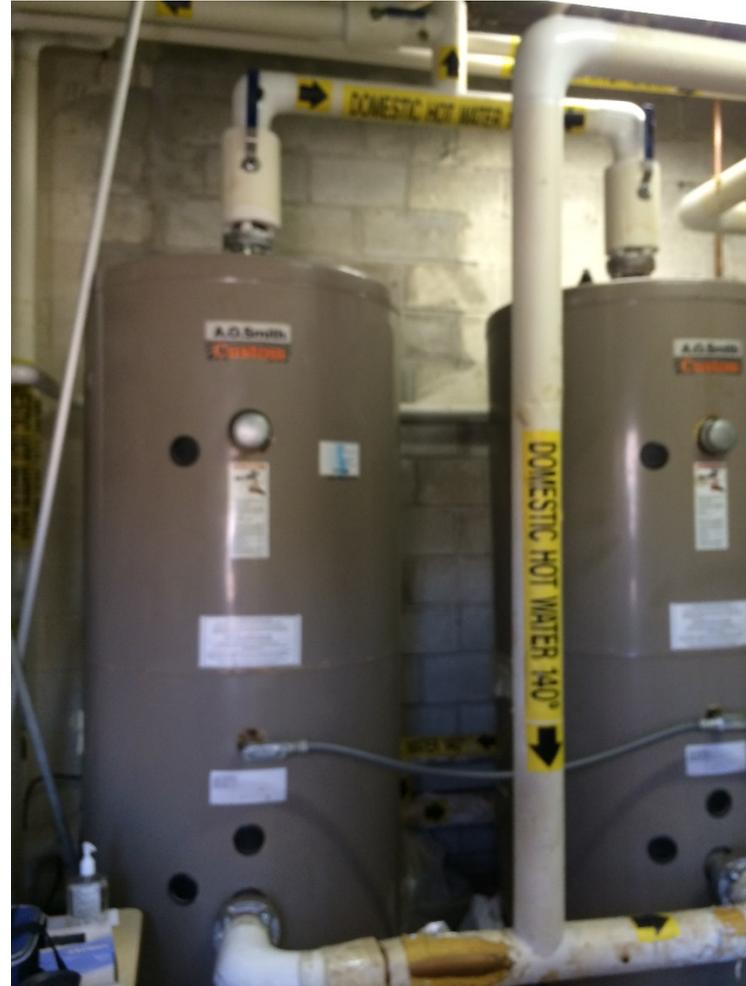
Boilers and associated storage tanks (not in image) due for replacement.
